Mobile Intel[®] Pentium[®] II Processor Specification Update

Release Date: October 2001

Order Number: 243887-034

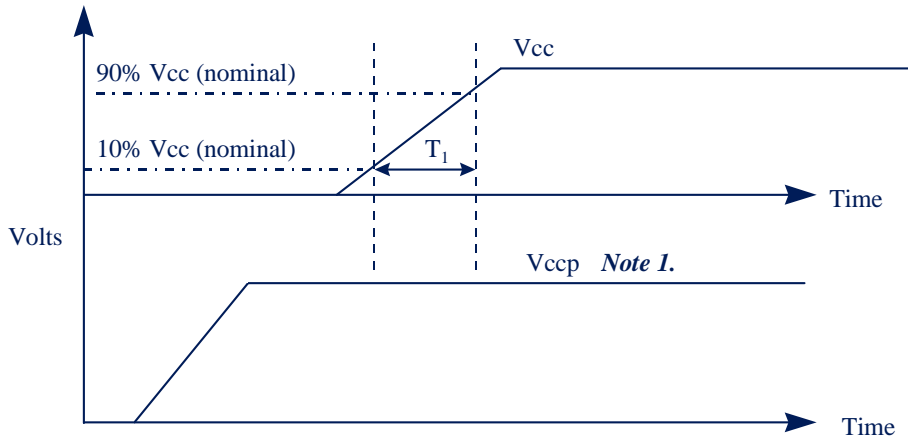
Figure 1. VCC/VCCP Timing Requirements (Mobile)

Problem: The processor uses the PWRGOOD signal to ensure that no voltage sequencing issues arise; no pin assertions should cause the processor to change its behavior until this signal is asserted, when all power supplies and clocks to the processor are valid and stable. However, if V_{CC} ramps up before V_{CCP} , it will cause the processor to enter an invalid state.

Implication: If this erratum occurs, the system may boot normally however, the L2 cache may not be initialized.

Workaround: For Mobile Pentium II processors, ensure that V_{CC} ramps after or with the L2 cache IO voltage (V_{CCP}). If V_{CCP} ramps after the V_{CC} , a delay circuit can be placed on the core V_{CC} to ensure that V_{CC} ramps at the same time or after V_{CCP} as shown below in Figure 1.

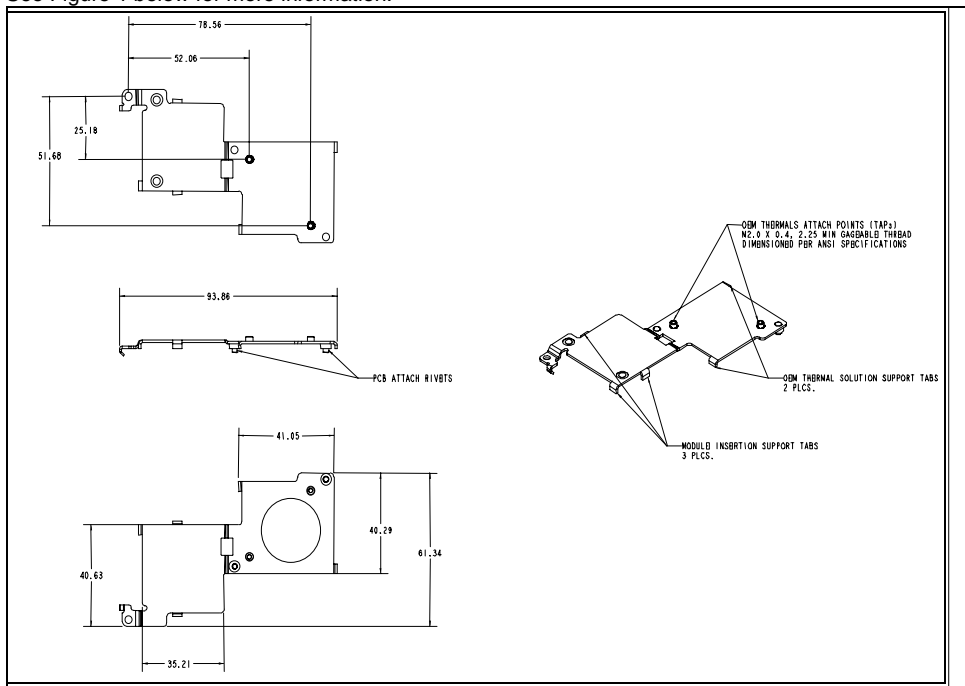
Figure 1. TAP Gageable Thread Clarification

OEM Thermal Attach Points (TAPs) M2.0 x 0.4, 2.25 min gageable thread dimensioned per ANSI specification.
